Nanoscale structures on ultra-precision machined fluorite surfaces

S Gritschneider¹, Y Namba² and M Reichling¹

Abstract

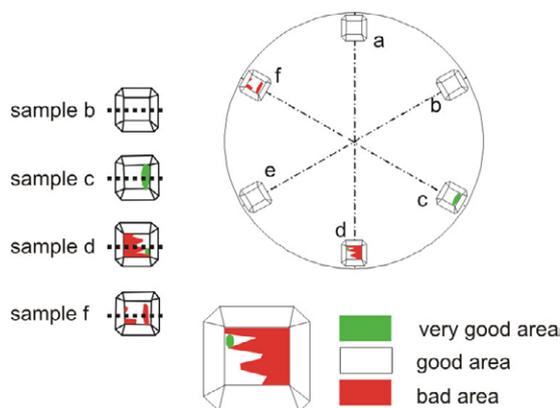
Figure 1. Six samples are symmetrically glued on the machining wheel to give all samples the same machining treatment. SFM measurements were performed at various positions along the dotted lines. The classification of ‘bad’, ‘good’ and ‘very good’ areas is a result of visual inspection with a Nomarski microscope.

We investigated six highest quality CaF_2 samples (labelled a, b, c, d, e, f) of $10 \times 10 \times 7 \text{ mm}^3$ dimensions provided by different vendors. After cleavage along the (111) plane, samples were glued in a circular arrangement onto a stainless steel machining wheel, as shown in figure 1, because we aimed for giving all of them exactly the same machining treatment. The samples were ground using an ultra-precision surface grinder [9] with an SD1500-75-B diamond wheel to obtain a flat plane among

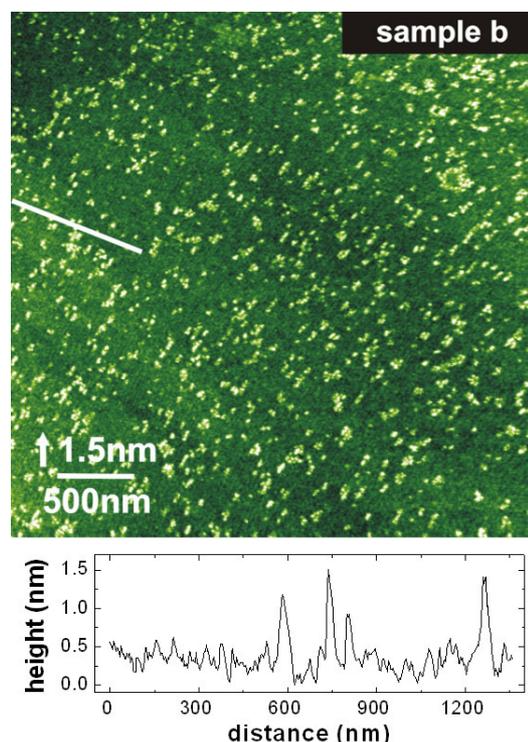
Figure 2. Typical appearance of $10\ \mu\text{m}^2$ of a machined surface as measured on sample b. The nearly atomically flat surface is covered with protrusions (bright spots) that are possibly a leftover from the machining process. Smaller surface features are aligned along unidirectional trenches of yet unidentified origin. Trenches are some nanometres wide and run probably over the entire surface. The line profile reveals the different scales of features determining surface roughness, namely a large number of triple-layer height pits and protrusions with a height of about $300\ \text{pm}$ and a small number of protrusions with a height of $1\text{--}2\ \text{nm}$.

Figure 2, representing results from sample b, shows a typical surface structure as we observe it regularly for good quality

areas. The topographic variation over the entire scanned area of $3.5 \times 3.5\ \mu\text{m}^2$ is extremely small compared to surfaces produced by cleavage or conventional polishing. As the dominant morphological feature, we observe protrusions of up to $1\ \text{nm}$ in height and some nanometres in lateral dimensions that randomly cover the surface.

The resulting RMS roughness of $0.3\ \text{nm}$ as evaluated from image analysis is, however, mainly determined by smaller scale surface features apparent upon closer inspection. Additional to the nanometre protrusions, the image reveals pits and protrusions with a height of about $300\ \text{pm}$ that are not randomly distributed across the surface but often line up along small trenches of a few nanometres width running straight across the surface. The direction of the trenches is the same over the entire machined area; however, we could not clearly identify a specific preparation step as the origin of the trenches. We anticipate that the larger protrusions are formed by leftovers from the surface treatment. A more quantitative analysis of topographic features is facilitated by the height profile included in figure 2. The dominance of up and down steps with $300\ \text{pm}$ height suggest that pits and protrusions are formed of F–Ca–F triple-layers (nominal height $315\ \text{pm}$) that are known to be stable building blocks of the fluorine terminated (111) surface. Best machining results shown in figure 3 were obtained on sample f, where the surface was not

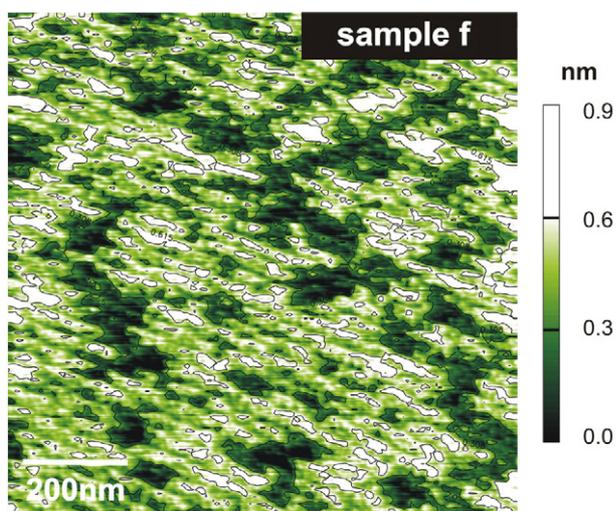
Figure 3. Highly resolved image of $1 \mu\text{m}^2$ in a good area imaged on sample f that yielded the best machining results. The scale bar covering a range of 0.9 nm reveals that all surface features can be associated with three different height levels separated by steps of 0.3 nm height.

found to be contaminated by larger features. This and similar images clearly demonstrate that large areas with a roughness of ± 1 triple-layer can be prepared by precision machining and subsequent float polishing. From the analysis of many scans of up to $10 \mu\text{m}^2$ in size taken at different regions of the crystal surfaces, we conclude that the actual area of nearly atomic flatness can be several hundred μm^2 and more.

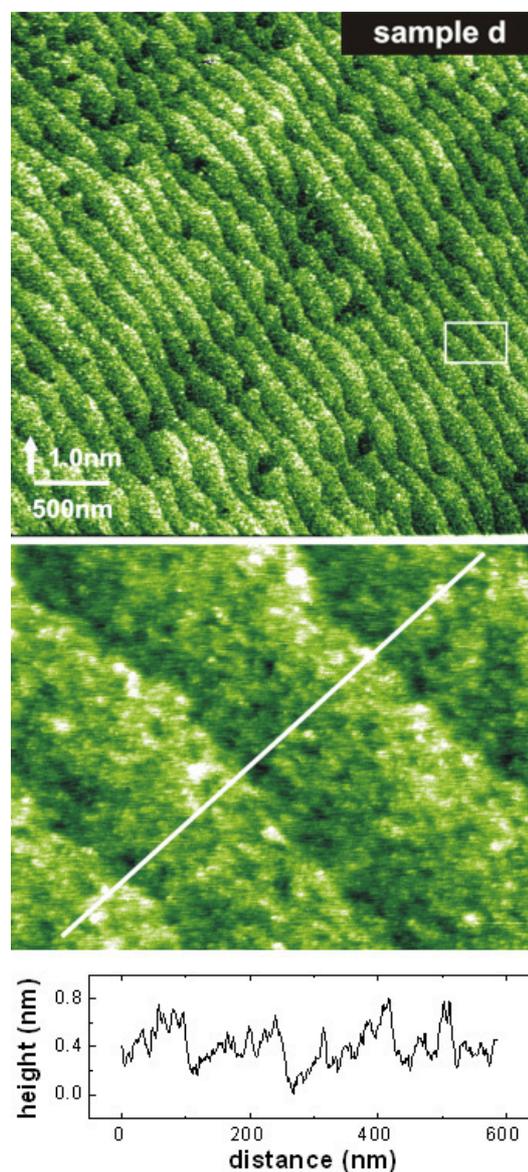
Figure 4. Misalignment of the machining plane and the surface of sample d results in the creation of a vicinal surface composed of a large number of aligned, triple-layer height steps. In this example, the surface inclination is about 5° . A cross-section was taken in a magnified area enclosed by the white rectangle.

A significantly different surface structure shown in figure 4 was found on sample d, exhibiting a regular array of terraces typical for a vicinal surface. The ridge structure found on the other surfaces could not be identified on this sample. The cross-section shown in figure 4 taken perpendicular to the direction of the step edges reveals a height difference of 0.31 nm between terraces, again corresponding to the triple-layer height. For this sample, apparently the machining plane and the (111) plane of the crystal were not well aligned. From the terrace width, we determine an inclination angle of about 5° with respect to the (111) plane that is most probably the result of a mistake when gluing the sample onto the machining wheel.

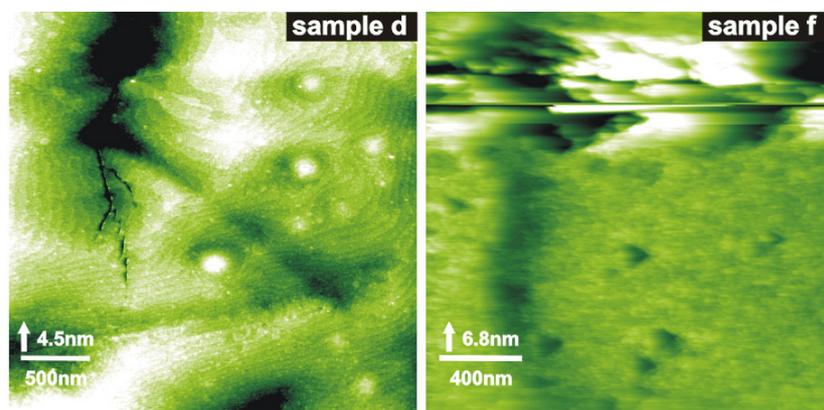
Figure 5. Areas of enhanced roughness as observed in bad areas of samples d and f. On sample d, machining is apparently hampered by large (some nanometres) protruding defects inhibiting controlled material removal in their vicinity. Stress induced by the enhanced interaction of the machining tool with the surface yields micro-cracks. On sample f, pit defects with a depth of some nanometres may also lead to uncontrolled SFM imaging results. The highly sensitive NC-SFM fails to examine a surface area of very high roughness like the one in the upper part of this frame.

Other machining-related defect structures found in bad regions of samples d and f that resulted in a tremendously increased surface roughness are shown in figure 5. On sample d, we recognize large defects surrounded by curved terraces having the appearance of height lines. Furthermore, we detect the remainder of a large triangular cleavage tip that has partially been flattened by polishing and machining. Apparently, the defects of a yet unknown origin heavily disturb the machining process and prevented a controlled removal of (111) layers. The observation of nanometre-sized cracks in the same region points to the build-up of a huge stress field due to the interaction of the machining tool with the defective region. These cracks appear as branched channels having directions that are not obviously related to any other surface feature. Similar defects are the reason for a high roughness shown on sample f. Here we again find a large cleavage step and adjacent defects of some ten nanometres in diameter. In this case, however, defects appear as pits, and in the upper part of the image, the defect structure

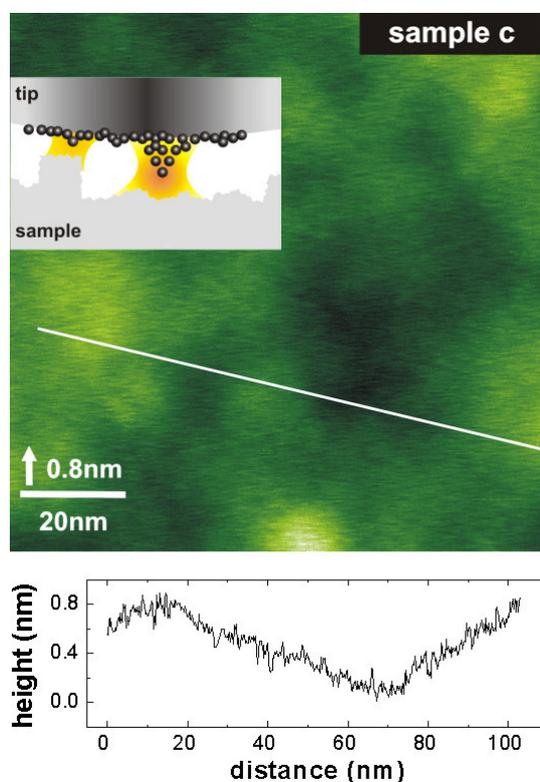
Figure 6. Highest resolution image taken in a very flat region of sample c. The size of the apparent surface features is determined by smearing effects due to the finite radius of the tip apex, as schematically illustrated by the inset. An interaction with more than one cluster may contribute to the total tip-sample interaction.

polished surfaces. As sketched in figure 6, one cannot assume that only the foremost nanotip contributes to the image contrast but other parts of the tip apex are interacting with the surface. Standard NC-SFM tips with tip radii of ten or more nanometres and with cone angles of 20° may be too coarse in this context. Super-sharp tips as have been introduced recently by different vendors could help to overcome this imaging problem in future studies; however, so far they could not prove their superiority in our experimental setup.
